Confidential Pre-Purchase Property Report

Complies with Australian Standard 4349.1 – 2007
Inspection of Buildings – Part 1: Pre-Purchase
Inspections – Residential Buildings

PRE-PURCHASE INSPECTION - RESIDENTIAL BUILDING REPORT

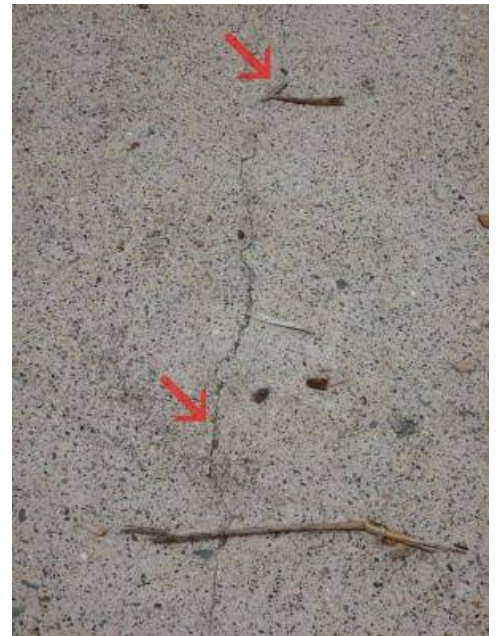
- Minor cracking has started to occur to the driveway. Monitor for further cracking or deterioration as a precautionary measure. Generally still good at this point in time however repairs may be required in the future if further deterioration occurs. Consult an engineer if further cracking starts to occur.

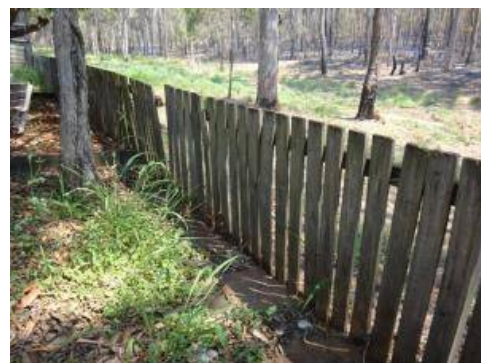
- Decay damage was noted to the fences. The degree of decay damage would be considered moderate at this point in time. Repairs will be required to prolong their life span. Consult a fencing contractor with regards to undertaking the necessary repairs.

- Repairs will be required to the wire fencing where deterioration has occurred to restore the fencing back to a satisfactory condition. Consult a fencing contractor with regards to undertaking the necessary repairs.

- Whilst we are not qualified pest inspectors there appears to be damage consistent with termite attack to the fence timbers. We strongly recommend that a licensed pest inspector be engaged to inspect the fences and dwelling as a precaution. Consult a fencing contractor with regards to undertaking the necessary repairs.

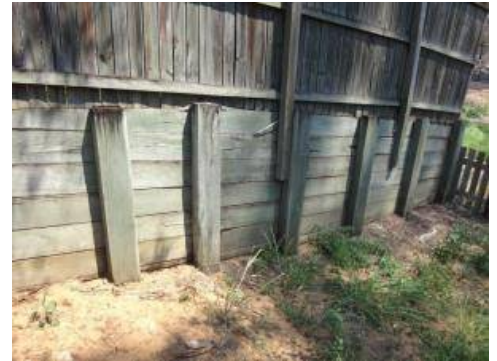
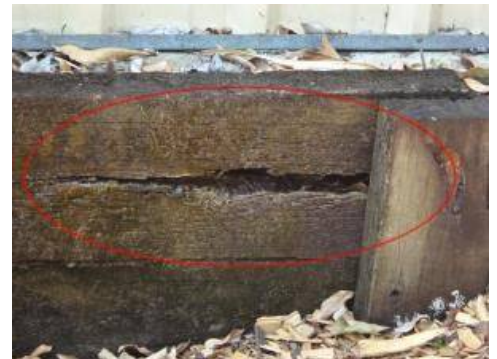
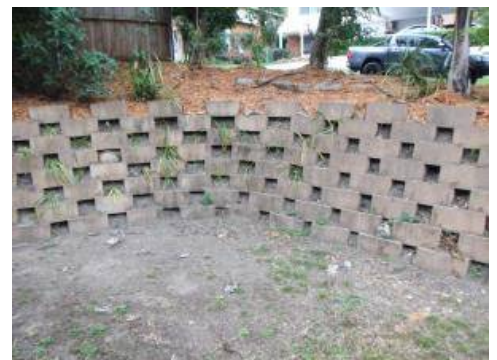
- The newer sleeper retaining walls appear in good order at this point in time. We would however recommend regular inspections on an annual basis to ascertain whether any deterioration is starting to occur e.g. outward movement.
- Decay damage was noted to the old timber retaining walls. The decay damage would be considered moderate at this point in time with more substantial damage occurring with the progression of time. Consult a landscaper or carpenter with regards to undertaking repairs to try and prolong the life span of the retaining walls.
- It is questionable as to how much drainage has been incorporated behind the retaining wall to prevent movement of the wall occurring. Additional drainage may be required behind the retaining walls to help control water flow and to alleviate pressure against the

retaining walls. Inadequate drainage could lead to premature wall deterioration eg. movement. Monitor the wall closely for premature deterioration due to possible inadequate drainage.

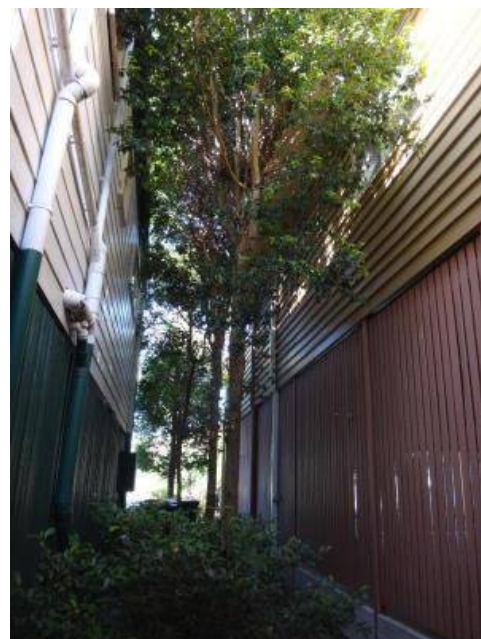
SURROUNDING TREES

- Closely monitor the roots from some of the larger trees around the house as they could potentially disturb the surrounding drains causing blockages or pipe fractures. Damage caused by tree roots can be costly to rectify if not addressed early. Large trees close to the house should ideally be removed.
- Some trees are too close to the house and will require subsequent removal to prevent potential damage occurring eg. foundation movement, plumbing damage etc. It should be noted that trees can cause considerable damage should their roots have an impact on the foundation material under and around the house eg. house subsidence and wall cracking etc.

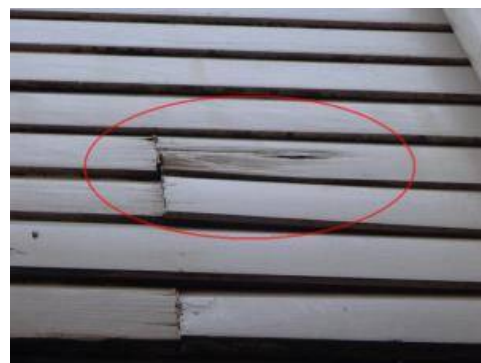
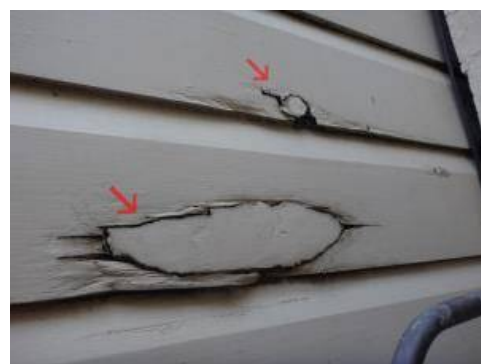
- Some of the wall cladding sits too close to ground level, leaving these areas vulnerable to moisture related damage and/or termite attack eg front elevation. As per AS3660, cladding should have 75 millimetres of ground clearance to help prevent deterioration and potential termite entry. Consideration should be given to options such as consulting a pest inspector with regards to upgrading termite barrier protection or where possible modifying the wall or cladding etc.

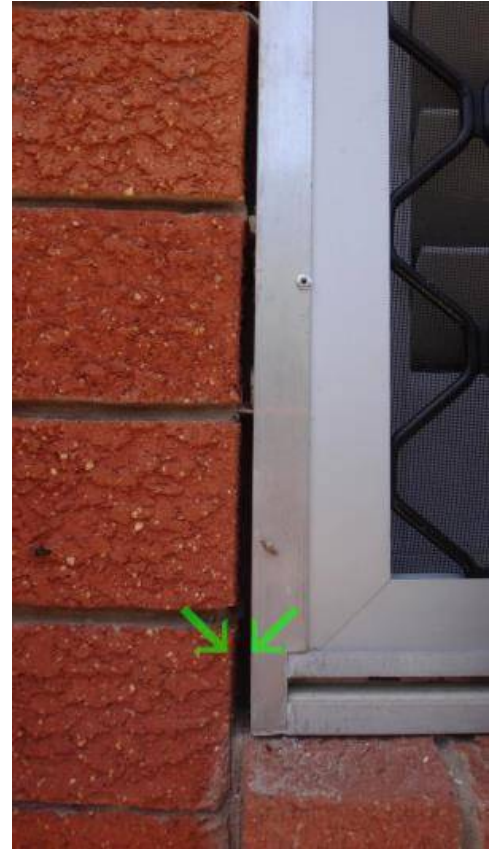
MASONRY MOVEMENT

- Repair and monitor the crack running through the masonry wall at the rear RH corner of the house. This particular crack ranges from hairline to approximately 6mm in width. Further consultation with an engineer will be required before any increase in the size of the crack occurs. Modifications and repairs are likely to be required to prevent further deterioration occurring eg remove the large tree adjacent to the wall and improve drainage where required to prevent retained moisture causing further subsidence.

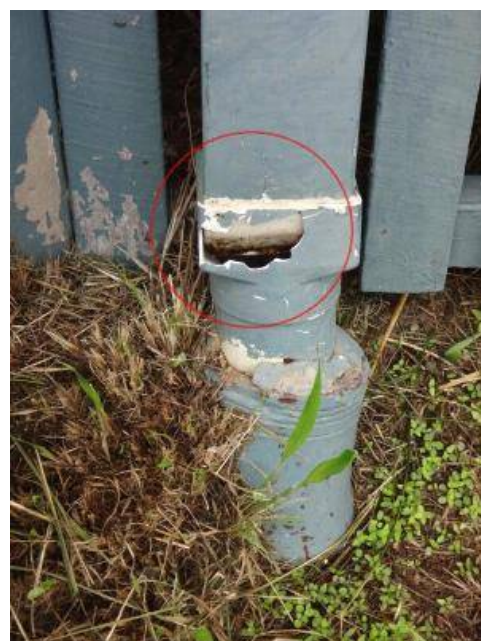
- Some of the stormwater collar connections have broken and require repair to prevent water leaks from the base of the downpipes. Ongoing downpipe leakage can contribute to foundation movement due to excessive moisture retention around the footings. Consult a plumber with regards to replacing the damaged collar connections.
- It is questionable as to the condition of the stormwater lines. We would recommend close monitoring during prolonged rain periods to establish whether they are still fully functional.
- We are unable to see below ground level to check for blockages or pipe breakages.

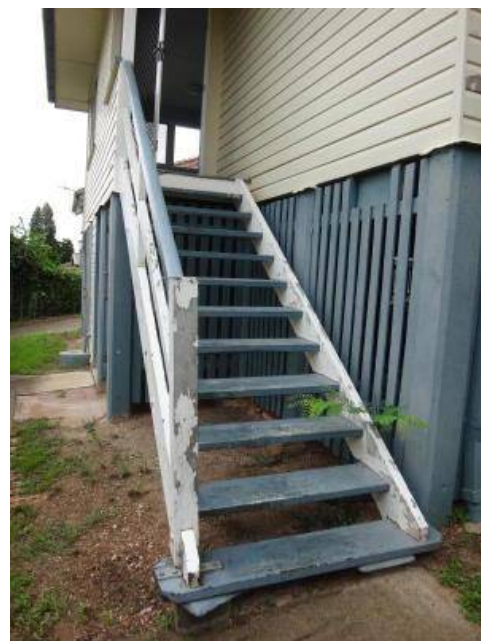
- Specifications have been laid down by the Australian Building Code Section 3.9 covering stairs, landings and balustrades to ensure the safety of all occupants and visitors in a building. Many balustrades and stairs built before 1996 may not comply with the current standard. In the interest of safety we would strongly recommend that all balustrades be upgraded to meet current standards.

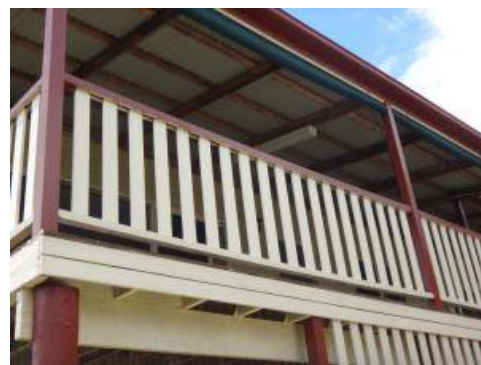
HANDRAILS

- The height of the hand railing does not comply with the current BCA standards. The current required height for a handrail above floor level is one metre. We would ideally recommend the handrail structure be upgraded to the current requirement as a safety precaution. Consult a carpenter with regards to undertaking the repairs where required.

- Additional fixings will be required to adequately secure the handrails to the posts to prevent possible movement or collapse occurring. Nails alone could prove to be inadequate, particularly as they rust with the progression of time. Install fixing brackets or more substantial screws. Consult a carpenter with regards to undertaking the modifications. Potential safety issue.

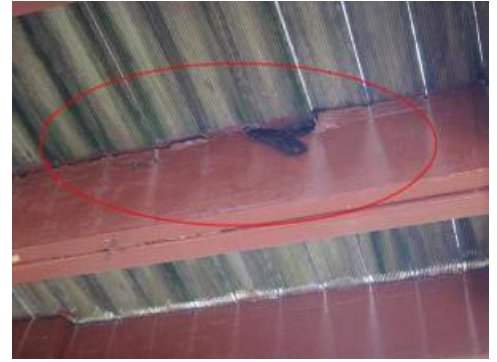
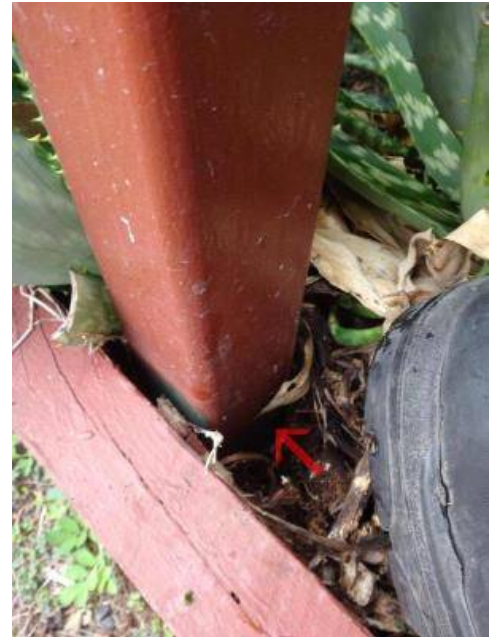
SUB FLOOR STRUCTURE

- Decay damage was noted to the deck sub floor structure eg floor joists. The decay damage would be considered moderate to significant at this point in time. Repairs will be required to prolong the life span of the veranda. Unrepaired decay damage will lead to more substantial deterioration occurring potentially jeopardising the structural integrity of the deck. Veranda structures should be inspected on an annual basis for deterioration. Consult a carpenter with regards to undertaking the necessary repairs.

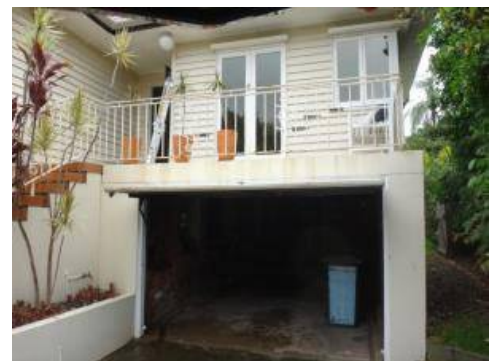
PATIO FRONT

- The patio structure was generally found to be in a sound condition at this point in time however does require repair to prevent further deterioration occurring. We would however recommend that the patio structure be inspected annually for signs of deterioration.

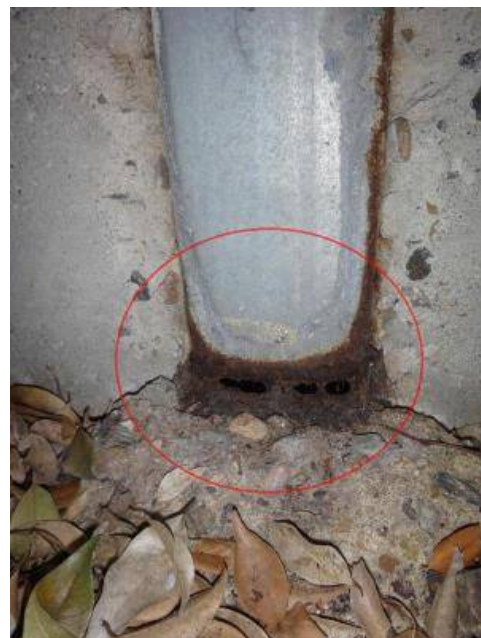
- Corrosion damage has occurred to the perimeter steel support posts. The degree of corrosion damage to the steel posts ranged from minor to significant at this point in time. Whilst rust repairs could be undertaken to some of the posts, replacement of the most affected steel posts will be required to maintain the house in a structurally sound condition eg approximately 7 posts to be replaced.
- Additional diagonal bracing will be required to the steel posts to help prevent lateral movement of the house. Further consultation with an engineer will be required to determine the best method and placement for the bracing.

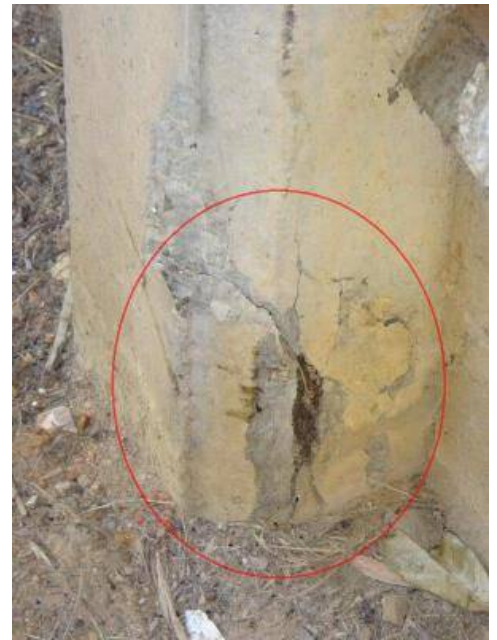
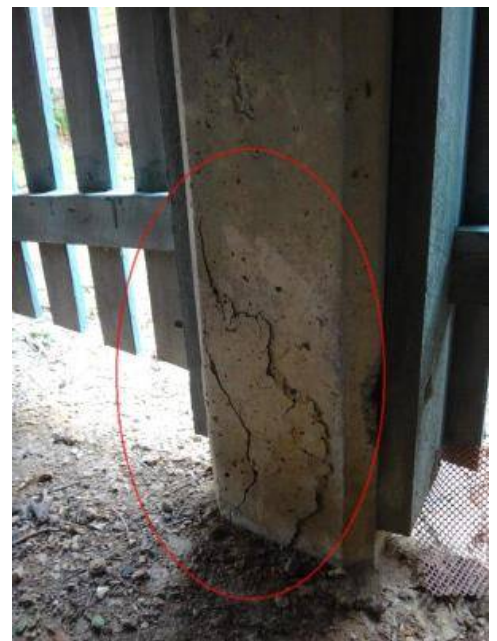
CONCRETE STUMPS

- Spalling damage was noted to the concrete stumps. The degree of spalling damage to the concrete stumps would be considered moderate to significant at this point in time. Repairs could be undertaken to try and prolong the lifespan of some stumps however replacement of the most effected stumps will be required eg approximately 6 stumps.
- Subsidence has started to occur to the concrete support stumps. The degree of subsidence would be considered moderate at this point in time. Repairs will be required to maintain the house in a level and stable condition. Some of the stumps will require replacement to prevent further settlement occurring.

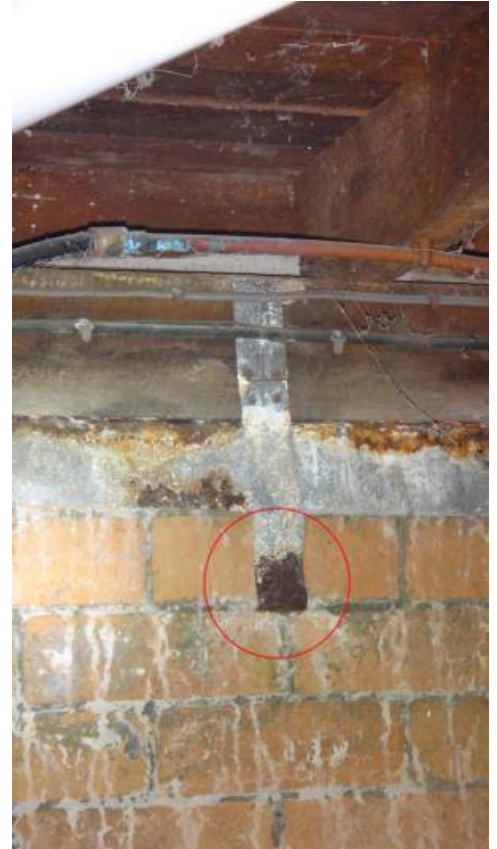
TIE DOWNS

- The tie down strapping has sustained corrosion damage and is therefore no longer adequate for the purpose of securing the house particularly given extreme storm conditions as the strength of the strapping has now been compromised. Repairs or alternative means of tie down will be required to maintain stability for the house eg bolt on threaded cyclone rods.

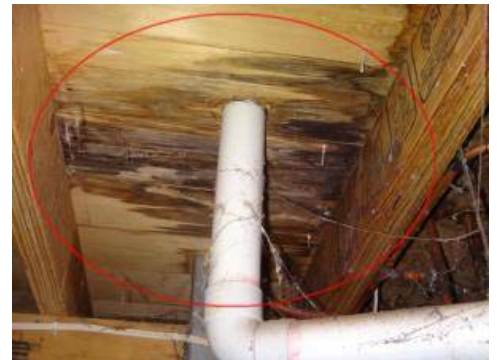
- Some water staining was noted to the underside of the bathroom floor area. Investigate the cause of the water staining and undertake repairs where required to prevent further water penetration and possible decay damage eg appears to be a leak from the main bathroom shower.

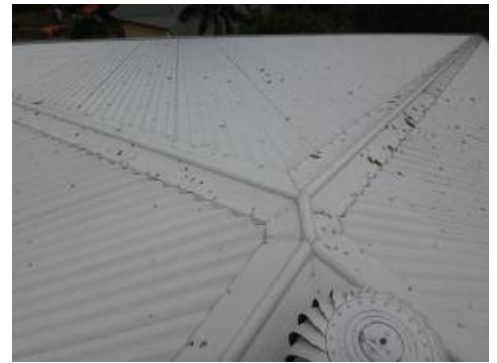
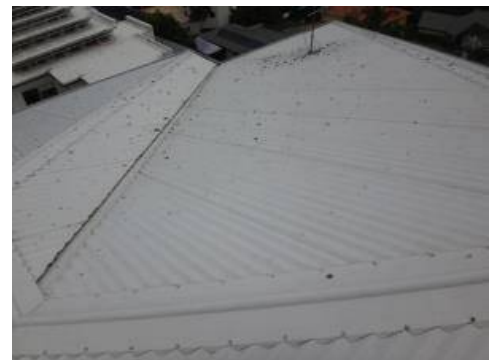
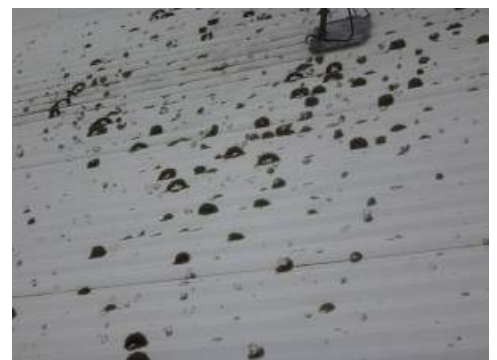
- The overall condition of the roof covering is good at this point in time however ideally requires a thorough clean to bring it back to a neat appearance.
- The roof ventilator (whirly bird) has seized and requires repair to bring it back to a functional condition and to prevent water leaks occurring during rain periods.

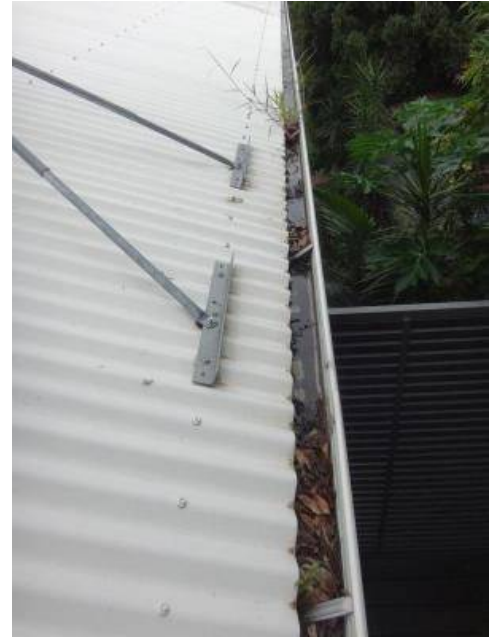
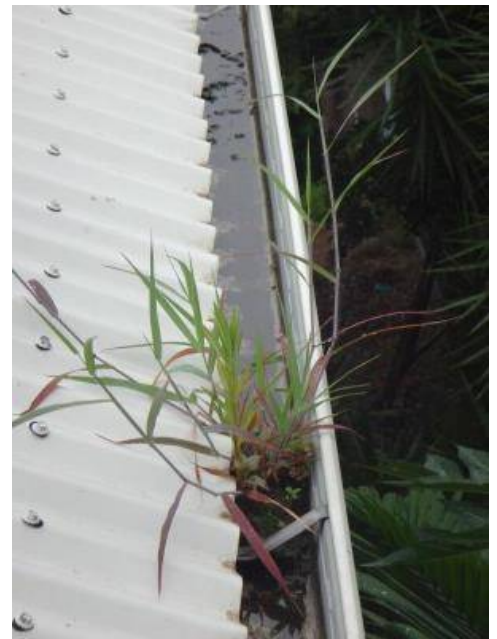
- Clean the leaf mulch out of the gutters to prevent blockages and possible water penetration within the roof. It should be noted that we were unable to adequately inspect the interior of the guttering as the leaf mulch prevented visual inspection. It is possible for corrosion to be concealed under all the leaf mulch. Further inspection is ideally required when the mulch has been removed.
- Install a gutter guard to the guttering around the roof to prevent debris build up within the guttering that could lead to premature corrosion or water overflow into the roof during rain periods.

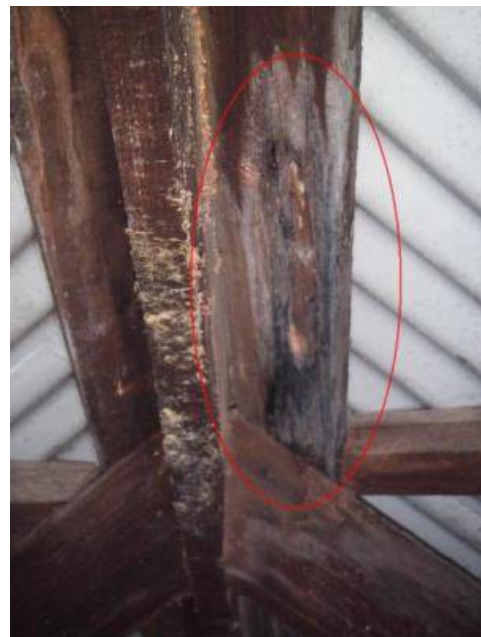
- Slight to moderate decay damage has started to occur to the roof battens. Monitor for further deterioration and undertake repairs where required eg replace some damaged ridge battens.

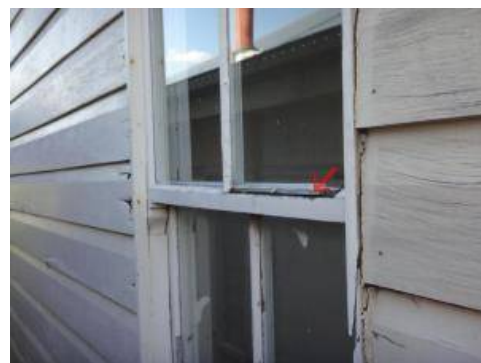
- Some windows were in extremely poor condition and could not be opened without the windows literally falling apart and the glass dislodging. Whilst some of the windows could be repaired others will require replacement eg front LH side and rear RH side bedrooms in particular. Lubricate and adjust the newer window sashes to maintain their ease of operation.
- Hood flashing and awnings were missing from above the windows. This is contributing to the water penetration occurring into the house walls during rain conditions. Large gaps around the deteriorating windows and an apparent lack of satisfactory flashing is also contributing to the water penetration.
- Glazing putty repairs will be required to help prevent decay and to prolong the life span of the glazing within the windows.
- Repairs will be required to some window latches to

- maintain at least basic security.
- Glazing in older houses (built before 1978) may not necessarily comply with current Glass Safety Standards AS1288. In the interests of safety, glass panes in doors and windows especially in trafficable areas should be replaced with safety glass or have shatterproof film installed unless they already comply with the current standard.

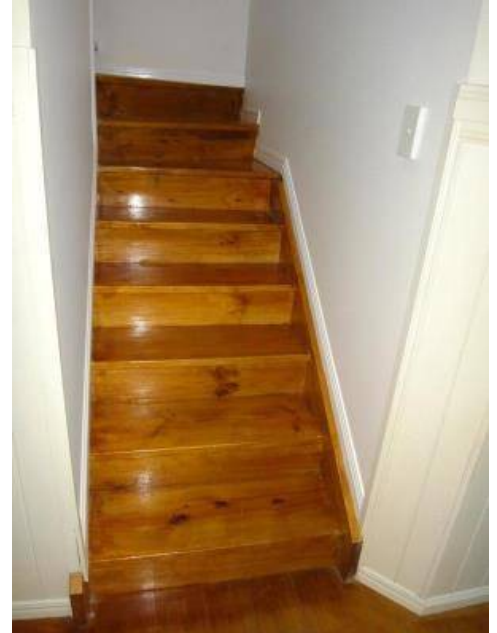
STAIRS & HANDRAILS

- The internal stairs were generally found to be in a satisfactory condition however install a handrail to the stairs where missing to prevent people potentially falling down the stairs. BCA requirement.

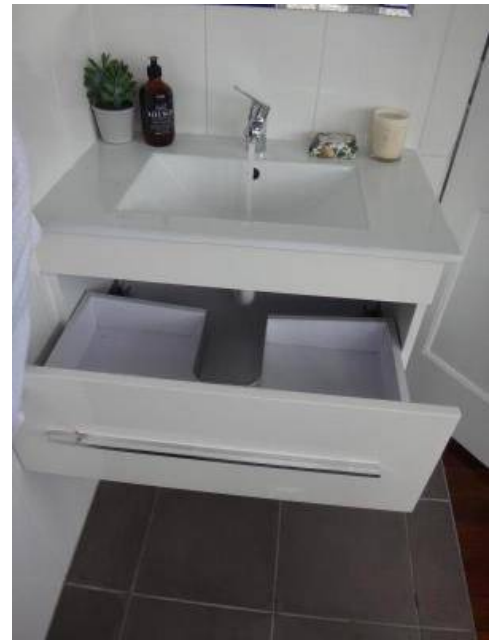
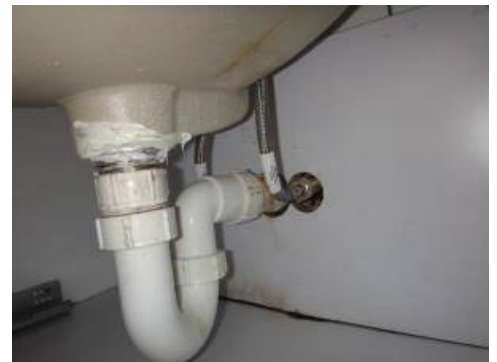
VANITY UNIT

- The condition of the vanity unit is generally good however slight water leakage was noted from the vanity waste where crude repairs have been undertaken. More appropriate repairs will be required before the water leak causes damage to the vanity unit.

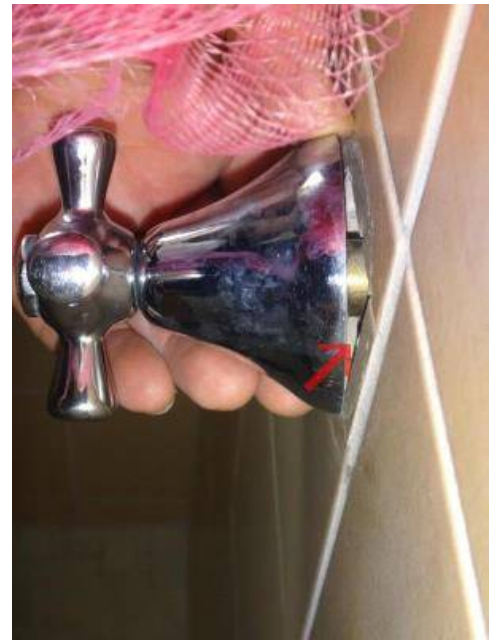
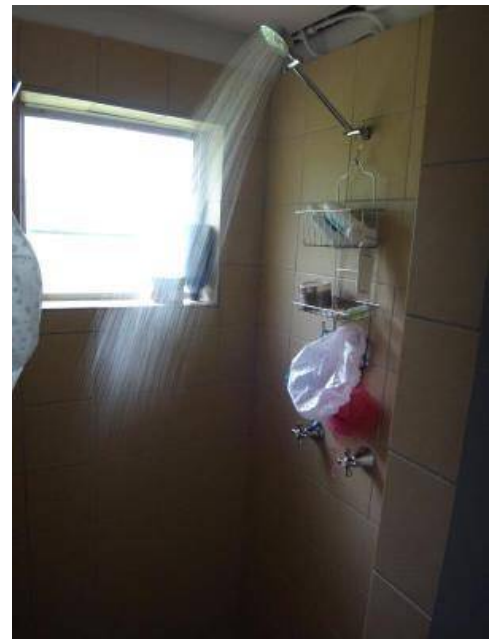
SHOWER

- Apply silicone around the body of the shower taps to prevent further water penetration into the walls and subsequent decay.
- There is evidence of water penetration into the wall/floor surrounding the shower. We would recommend further investigation to determine the extent of what appears to be a shower flashing leak. Unrepaired water penetration could lead to more substantial decay and possible termite attraction. It is possible that some degree of decay damage may have started to occur within the wall at this point in time. Investigate further.

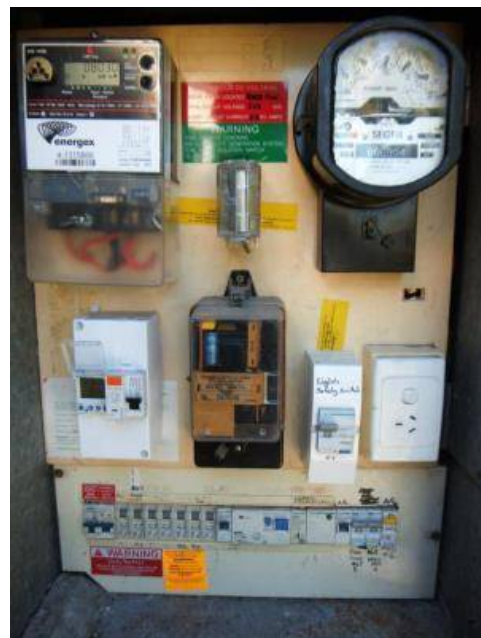
- A residual current device appears to have been installed to the house. We would recommend regular testing of the safety switch to ensure it remains in a fully functional condition. It should however be noted that we were unable to legally test the operation of the safety switch during the course of our inspection. Investigate further.
- Some cracked switch plates ideally require replacement as a safety precaution eg kitchen stove isolator switch.
- We would recommend an independent electrical inspection be carried out by a licensed electrician prior to purchase of the property as a precautionary measure.
- Some crude wiring modifications have been undertaken eg exposed backing to the power points within the roof space. We would recommend further inspection and subsequent repairs undertaken where required. Hazardous. Safety issue.

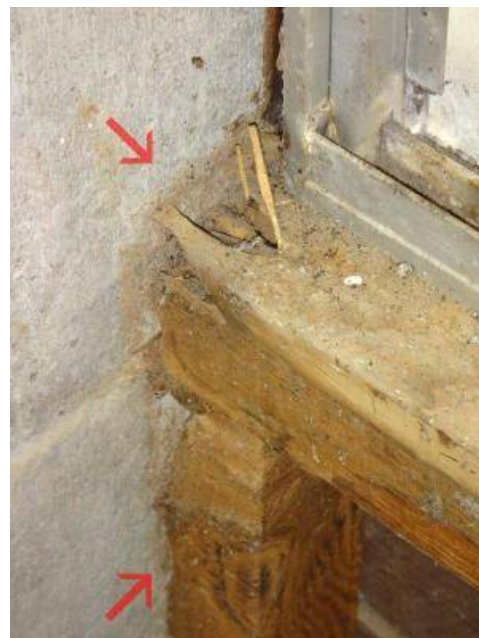
- There was no termite treatment label within the metre box. Investigate further to establish the extent of any previously installed termite barriers.
- We would recommend further consultation with a pest inspector to determine the extent of what appears to be termite evidence within the subfloor area. It should be noted that as we are not pest inspectors, we are not able to comment with certainty or in detail about pest matters.
