Confidential Pre-Purchase Property Report

Complies with Australian Standard 4349.1 – 2007
Inspection of Buildings – Part 1: Pre-Purchase
Inspections – Residential Buildings

PRE-PURCHASE INSPECTION - RESIDENTIAL BUILDING REPORT

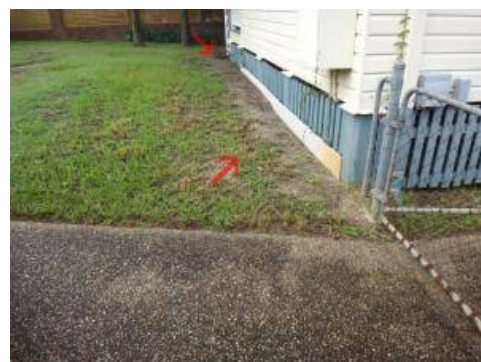
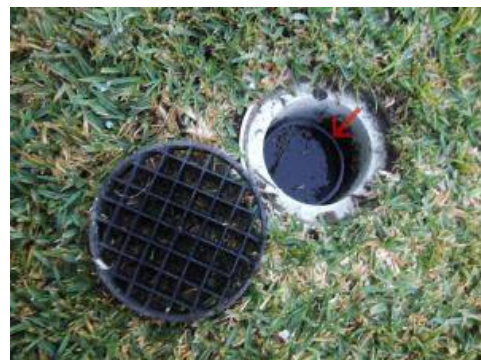
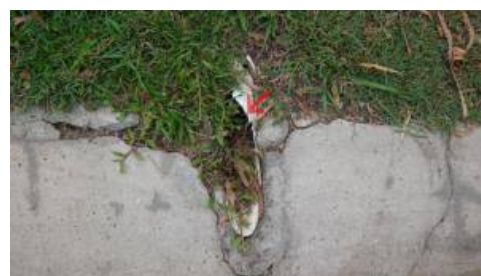
- The drainage across the rear of the property will require improvement to prevent water flow into the sub floor area. Inadequate drainage around the house could lead to moisture retention and subsequent foundation movement or possible termite attraction. The installation of agricultural pipe and or gully trap drainage boxes could help alleviate excessive moisture retention. Consult a plumber with regards to undertaking the necessary repairs.

- The existing stormwater drains appear to be at least partially blocked and require further investigation and subsequent repairs to bring them back to a fully functional condition. Consult a plumber with regards to undertaking the necessary repairs.

- The kerb side drain appears blocked/damaged and requires repair to bring it back to a satisfactory condition. A plumber could undertake the necessary repairs.

- The retention of water from surface run off could have an effect on the foundation material which in turn could affect the footings to the house. Best practice is to

monitor the flow of surface water and stormwater run off and have the water directed away from the house or to storm water pipes by a licensed plumber/drainier.

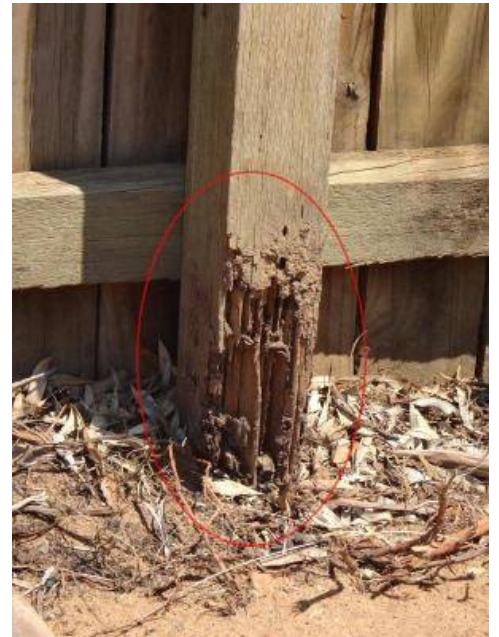
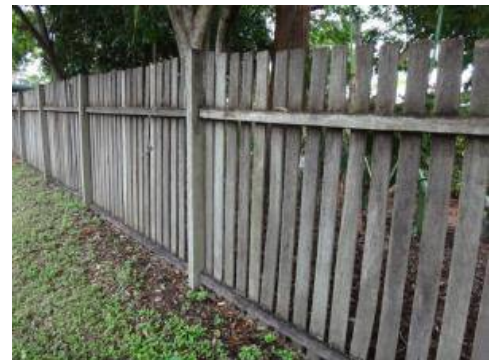
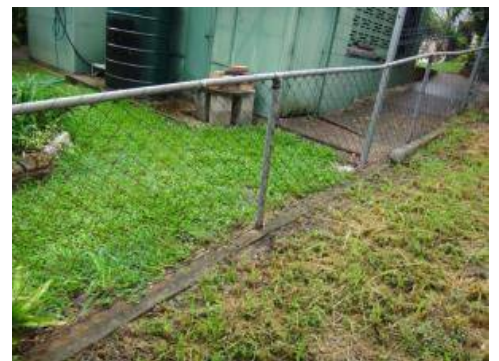
FENCES AND GATES

- Decay damage was noted to the fences. The degree of decay damage would be considered moderate at this point in time. Repairs will be required to prolong their life span. Consult a fencing contractor with regards to undertaking the necessary repairs.

- Repairs will be required to the wire fencing where deterioration has occurred to restore the fencing back to a satisfactory condition. Consult a fencing contractor with regards to undertaking the necessary repairs.

- Whilst we are not qualified pest inspectors there appears to be damage consistent with termite attack to the fence timbers. We strongly recommend that a licensed pest inspector be engaged to inspect the fences and dwelling as a precaution. Consult a fencing contractor with regards to undertaking the necessary repairs.

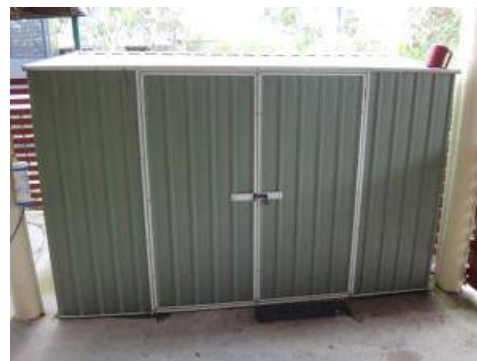
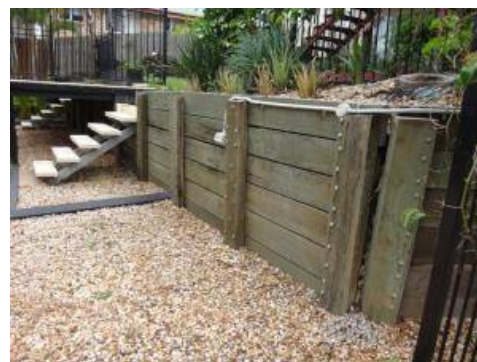
RETAINING WALLS

- The newer sleeper retaining walls appear in good order at this point in time. We would however recommend regular inspections on an annual basis to ascertain whether any deterioration is starting to occur e.g. outward movement.
- Decay damage was noted to the old timber retaining walls. The decay damage would be considered moderate at this point in time with more substantial damage occurring with the progression of time. Consult a landscaper or carpenter with regards to undertaking repairs to try and prolong the life span of the retaining walls.
- It is questionable as to how much drainage has been incorporated behind the retaining wall to prevent movement of the wall occurring. Additional drainage may be required behind the retaining walls to help control water flow and to alleviate pressure against the

retaining walls. Inadequate drainage could lead to premature wall deterioration eg. movement. Monitor the wall closely for premature deterioration due to possible inadequate drainage.

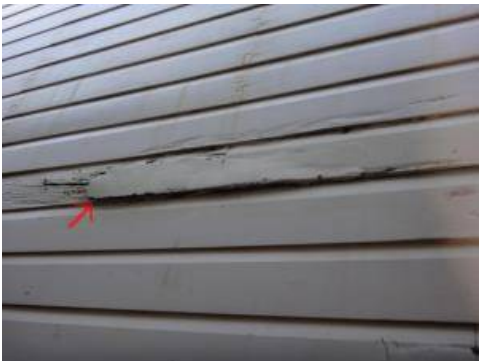
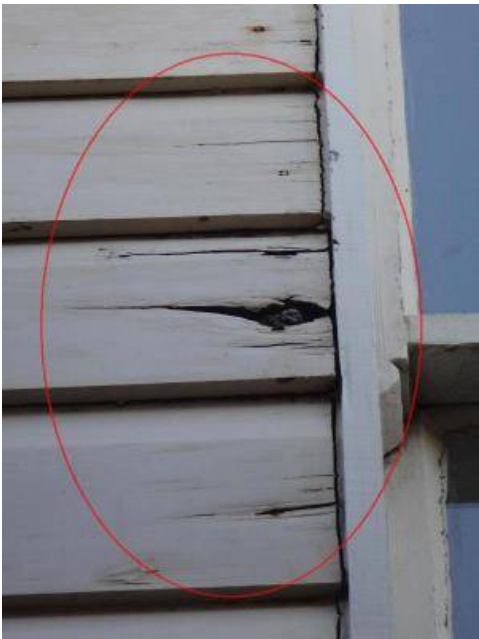
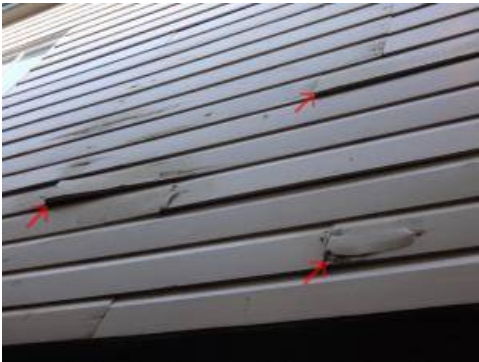
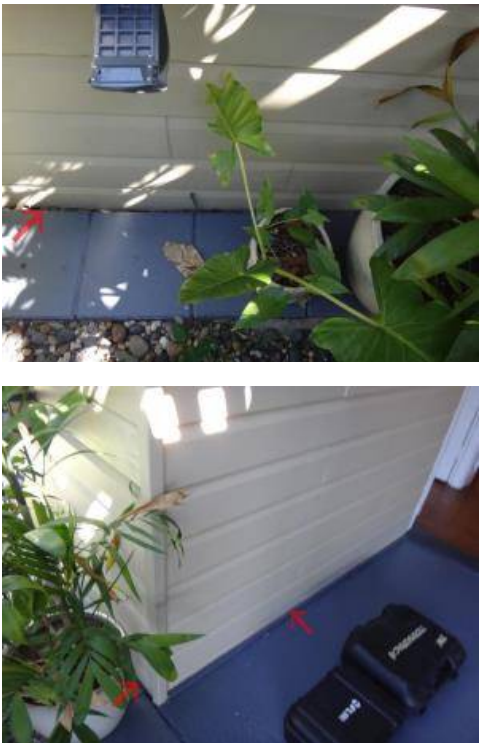
- Some of the wall cladding sits too close to ground level, leaving these areas vulnerable to moisture related damage and/or termite attack eg front elevation. As per AS3660, cladding should have 75 millimetres of ground clearance to help prevent deterioration and potential termite entry. Consideration should be given to options such as consulting a pest inspector with regards to upgrading termite barrier protection or where possible modifying the wall or cladding etc.

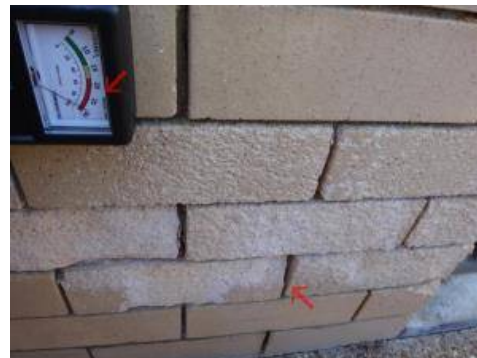
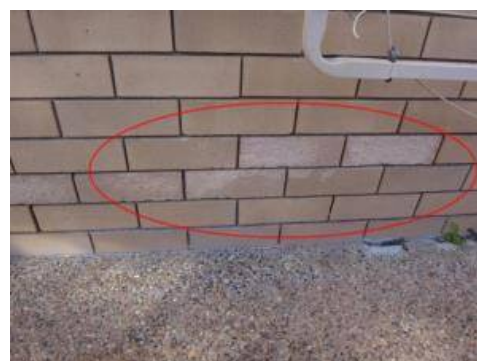
MASONRY WALLS

- Rising damp was noted on some of the brickwork at various locations around the house. Further consultation with a bricklayer or specialist in waterproofing should be undertaken before the rising damp becomes significant. It should be noted that prolonged dry weather conditions may not adequately show up rising damp problems in the surrounding walls. Rising damp may become more evident after prolonged rain periods. Monitor as a precaution and undertake repairs if required to prevent further damage occurring eg. wall fretting etc. Silicone injection around the damp course line, or similar methods of rectification can be used to prevent rising damp should it become excessive.

- Some of the brickwork was fretting eg rear elevation. Modifications/repairs will be required to prolong the life span of the fretting brickwork eg. silicone injection of walls or replacing damaged brickwork. Further consultation with a bricklayer or specialist in waterproofing will be required to ascertain the best method of monitoring and repair. Monitor for further deterioration as a precaution. It is likely that further deterioration will occur with the progression of time unless modifications/repairs are undertaken.

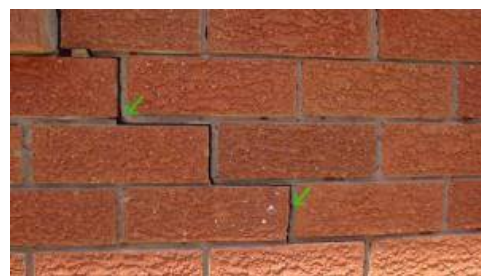
MASONRY MOVEMENT

- Repair and monitor the crack running through the masonry wall at the rear RH corner of the house. This particular crack ranges from hairline to approximately 6mm in width. Further consultation with an engineer will be required before any increase in the size of the crack occurs. Modifications and repairs are likely to be required to prevent further deterioration occurring eg remove the large tree adjacent to the wall and improve drainage where required to prevent retained moisture causing further subsidence.

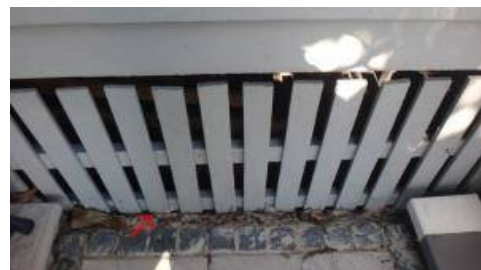
- Some of the infill panels have ground contact leaving them vulnerable to premature decay and termite attack. Consult a carpenter with regards to trimming the panels at least 75 millimetres above ground level to help prevent decay and termite damage.

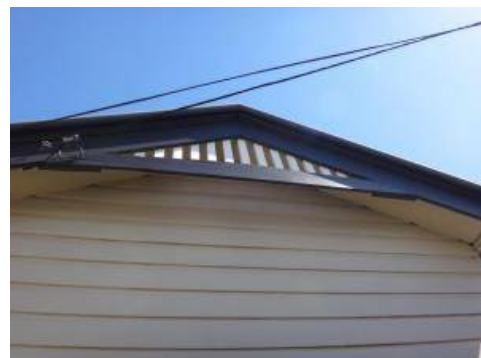
GABLE STRUCTURE

- Slight splitting and cosmetic decay/deterioration has started to occur to the barge boards. Cosmetic repairs will be required to prolong their lifespan.

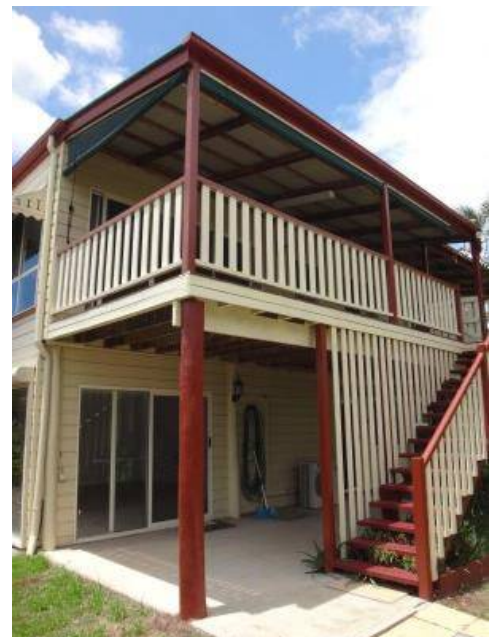
HANDRAILS

- The height of the hand railing does not comply with the current BCA standards. The current required height for a handrail above floor level is one metre. We would ideally recommend the handrail structure be upgraded to the current requirement as a safety precaution. Consult a carpenter with regards to undertaking the repairs where required.

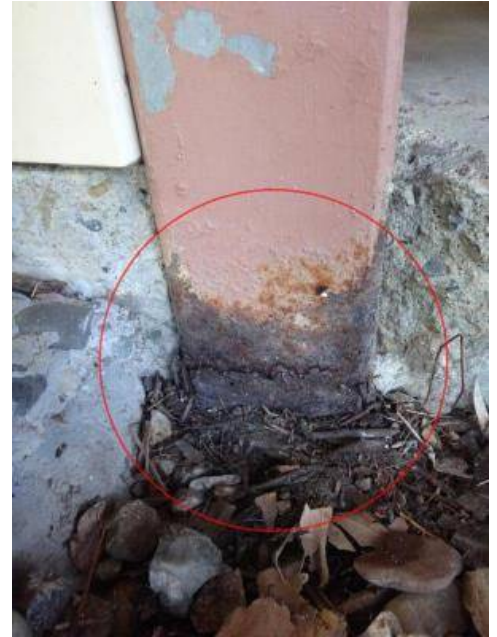
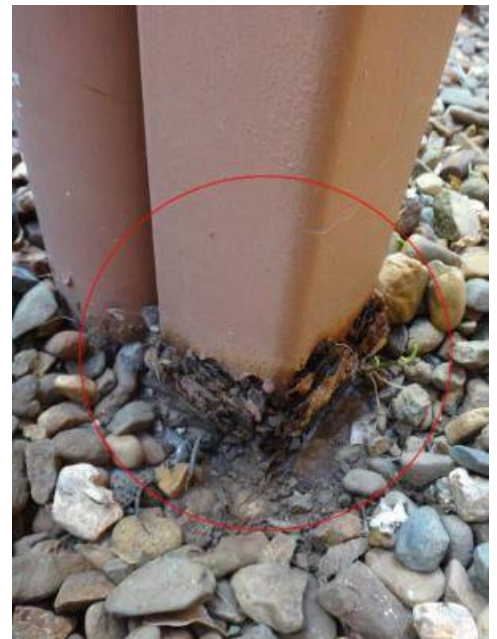
- Corrosion damage has occurred to the perimeter steel support posts. The degree of corrosion damage to the steel posts ranged from minor to significant at this point in time. Whilst rust repairs could be undertaken to some of the posts, replacement of the most affected steel posts will be required to maintain the house in a structurally sound condition eg approximately 7 posts to be replaced.
- Additional diagonal bracing will be required to the steel posts to help prevent lateral movement of the house. Further consultation with an engineer will be required to determine the best method and placement for the bracing.

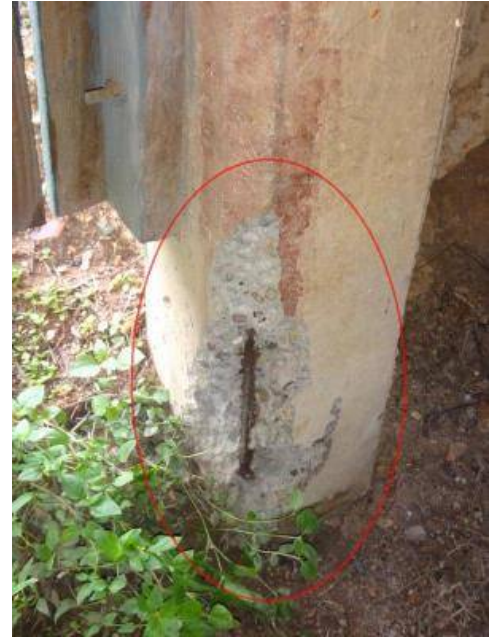
CONCRETE STUMPS

- Spalling damage was noted to the concrete stumps. The degree of spalling damage to the concrete stumps would be considered moderate to significant at this point in time. Repairs could be undertaken to try and prolong the lifespan of some stumps however replacement of the most effected stumps will be required eg approximately 6 stumps.
- Subsidence has started to occur to the concrete support stumps. The degree of subsidence would be considered moderate at this point in time. Repairs will be required to maintain the house in a level and stable condition. Some of the stumps will require replacement to prevent further settlement occurring.

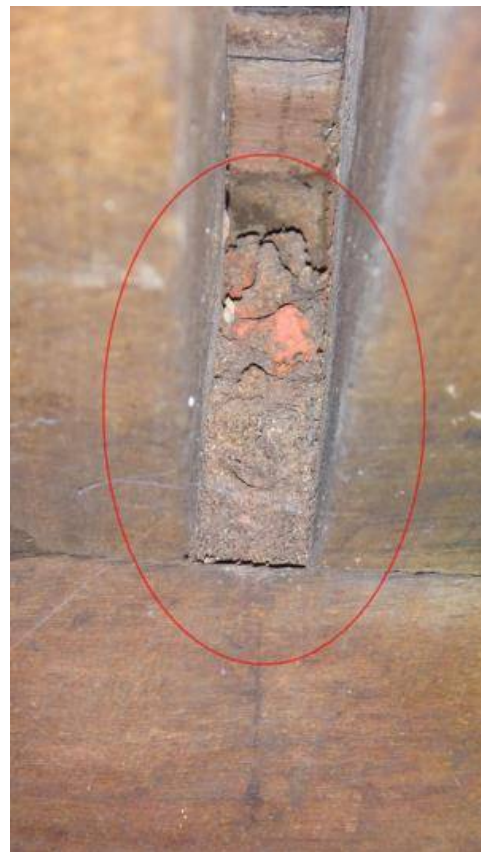
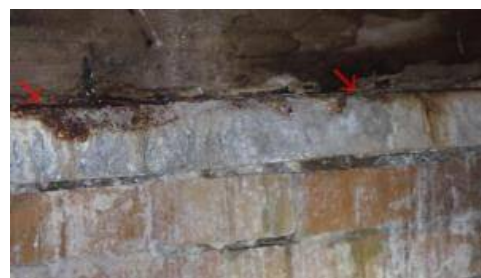
- There is inadequate termite protection to this house to prevent potential termite entry. Consult a pest inspector with regards to upgrading termite barrier protection as a precaution. Inadequate protection leaves this house vulnerable to termite attack.

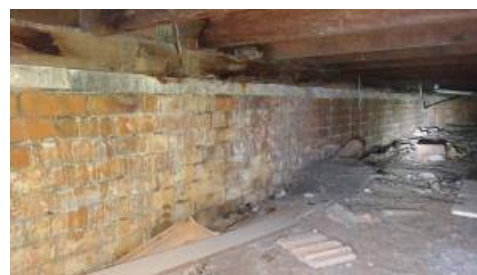
- The foundation walls were generally found to be in a sound condition at this point in time. Regular monitoring will however still be required.
- There is evidence of moderate moisture penetration occurring through the foundation walls. Future repairs will be required to prevent further moisture penetration occurring. Moisture penetration can contribute to termite attraction or wall deterioration eg brick fretting.

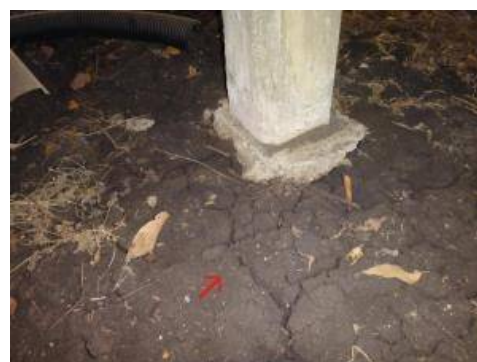
- There is some evidence of water penetration occurring through the subfloor area. Improved drainage will be required to prevent further water penetration during rain periods. Water flow under the house will contribute to house movement, mould and fungi issues, decay and termite attraction.
- Ventilation is important in minimising infestations by timber pests and helps prevent damp problems. Ventilation should always be maintained to a subfloor area.

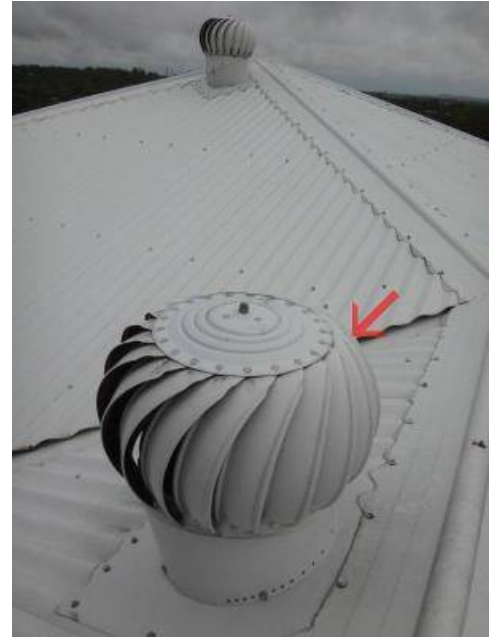
- The overall condition of the roof covering is good at this point in time however ideally requires a thorough clean to bring it back to a neat appearance.
- The roof ventilator (whirly bird) has seized and requires repair to bring it back to a functional condition and to prevent water leaks occurring during rain periods.

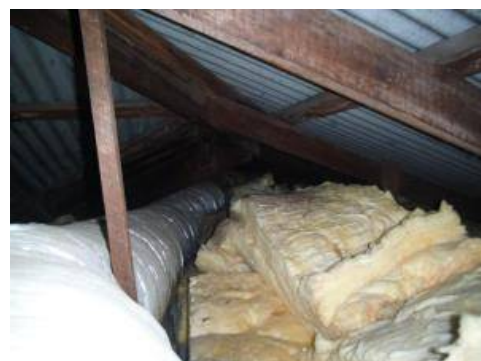
ROOF STRUCTURE

- The internal roof structure generally appears to be sound at this point in time. Slight undulation of the roof structure was however noted. Monitor for further roof undulation as a precaution and undertake repairs should further undulation or deflection start to occur. Generally still sound at this point in time. Consult an engineer should further deflection occur.

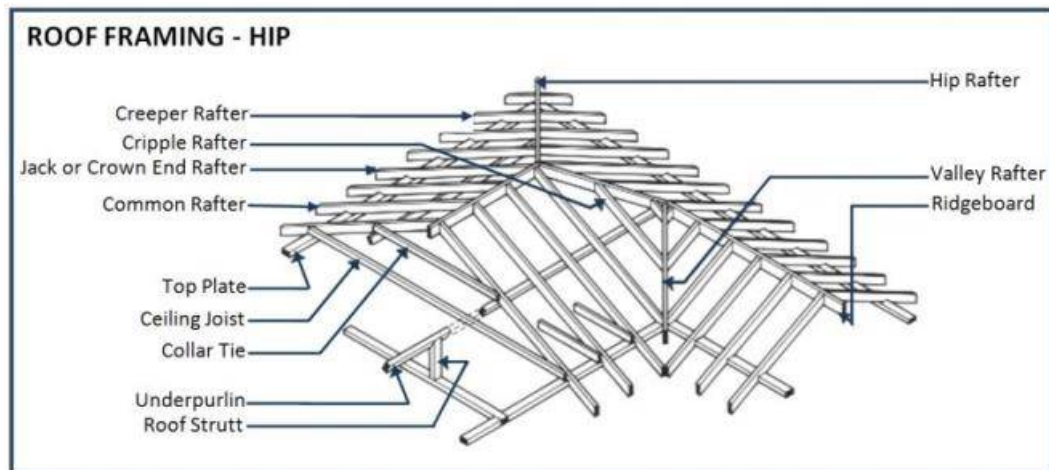
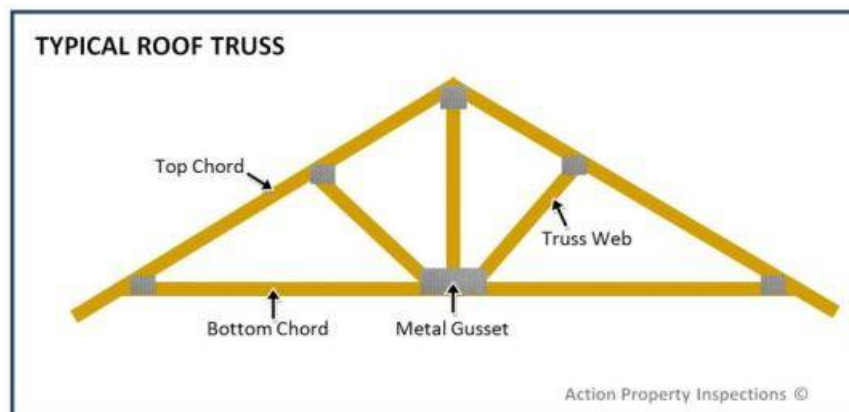
DECAY

- Slight to moderate decay damage has started to occur to the roof battens. Monitor for further deterioration and undertake repairs where required eg replace some damaged ridge battens.

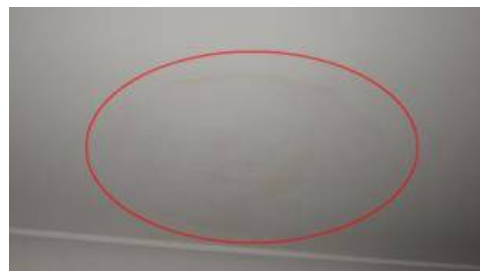
- There is some evidence of what appears to have been internal water penetration to the ceiling at some locations eg front main bedroom. Undertake repairs to prevent further water penetration followed by cosmetic rectification of the water staining/damage. Depending on the cause of the water stain this may involve various trades e.g. plasterer, painter and roofer etc
- Hairline cracks were noted to some cornices eg, mitred joints. Cosmetic repairs will eventually be required with a product such as plaster or No More Gaps to conceal the hairline cracks. Generally still sound at this point in time.

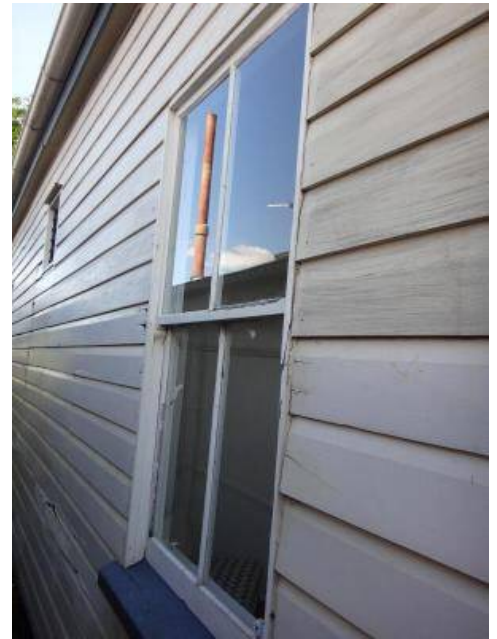
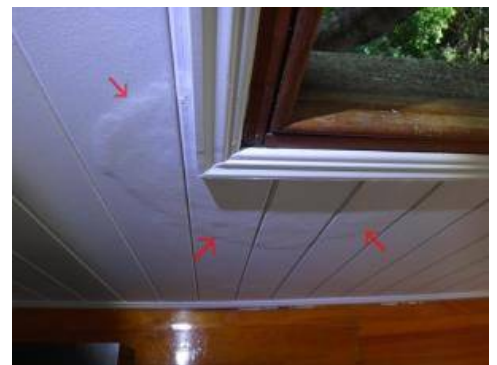
- Some windows were in extremely poor condition and could not be opened without the windows literally falling apart and the glass dislodging. Whilst some of the windows could be repaired others will require replacement eg front LH side and rear RH side bedrooms in particular. Lubricate and adjust the newer window sashes to maintain their ease of operation.
- Hood flashing and awnings were missing from above the windows. This is contributing to the water penetration occurring into the house walls during rain conditions. Large gaps around the deteriorating windows and an apparent lack of satisfactory flashing is also contributing to the water penetration.
- Glazing putty repairs will be required to help prevent decay and to prolong the life span of the glazing within the windows.
- Repairs will be required to some window latches to

- maintain at least basic security.
- Glazing in older houses (built before 1978) may not necessarily comply with current Glass Safety Standards AS1288. In the interests of safety, glass panes in doors and windows especially in trafficable areas should be replaced with safety glass or have shatterproof film installed unless they already comply with the current standard.

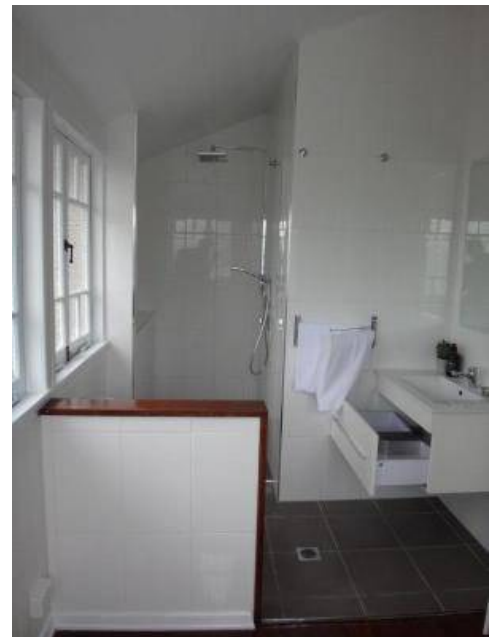
VANITY UNIT

- The condition of the vanity unit is generally good however slight water leakage was noted from the vanity waste where crude repairs have been undertaken. More appropriate repairs will be required before the water leak causes damage to the vanity unit.

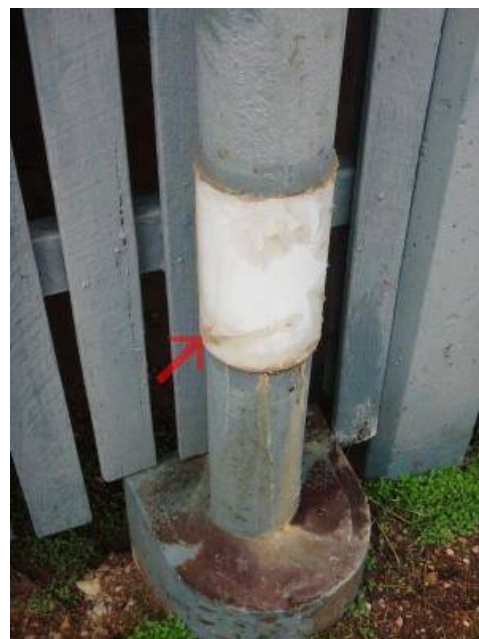
- Evidence of previous patching was noted to the sewer vent pipe. This often indicates previous blockages and subsequent repairs with the aid of an electric eel. The eel is a device placed through the stormwater line to chew out tree roots and debris in an attempt to at least temporarily clear the blockages. Eventual sewer line replacement may be required should further deterioration or blockages occur.

- Some crude plumbing alterations appear to have been undertaken within the sub floor of the house. We would recommend further investigation and subsequent repairs undertaken where required to ensure the plumbing is in a compliant and fully functional condition.

- The house still retains galvanized iron water pipes. Eventual pipe replacement will be required as deterioration of these pipes occurs. Monitor their condition closely.

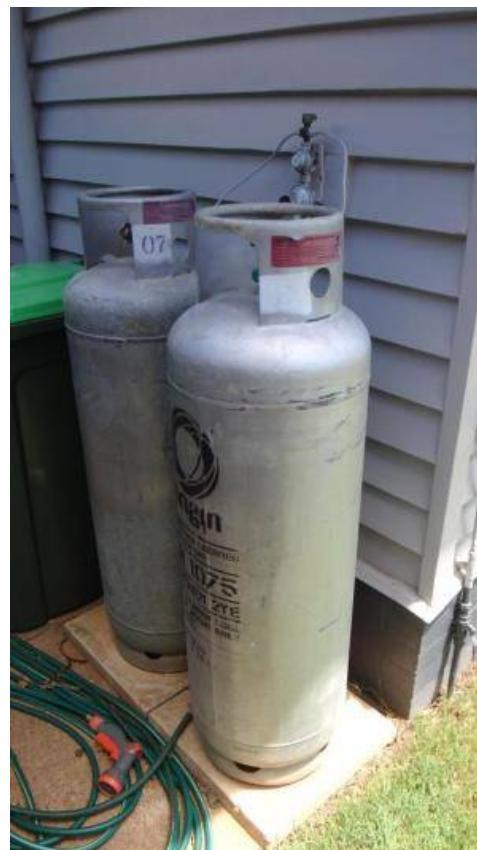
- A bottle gas supply has been installed to the premises. Regular inspections and maintenance of the bottle gas connections will be required as a precautionary measure.
- We would recommend the installation of a chain or securing strap to adequately secure the LPG bottles in position to prevent them potentially being knocked over. Potential safety issue and must comply with AS5601.1. If the bottles fall over the attached gas lines may rupture or the heavy cylinders could crush a small child.
- We would recommend an independent gas inspection be carried out by licensed plumber prior to purchase of the property as a precautionary measure.

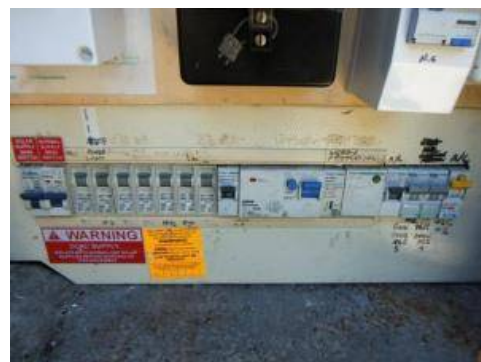
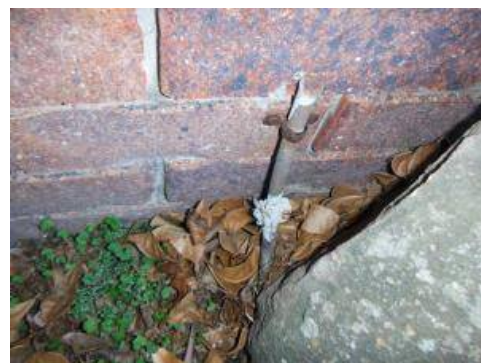
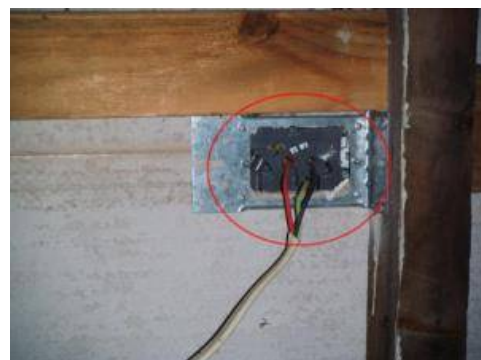
POWER BOARD/WIRING

Unable to be inspected, Further Inspection Required. Safety Hazard.

- A residual current device appears to have been installed to the house. We would recommend regular testing of the safety switch to ensure it remains in a fully functional condition. It should however be noted that we were unable to legally test the operation of the safety switch during the course of our inspection. Investigate further.
- Some cracked switch plates ideally require replacement as a safety precaution eg kitchen stove isolator switch.
- We would recommend an independent electrical inspection be carried out by a licensed electrician prior to purchase of the property as a precautionary measure.
- Some crude wiring modifications have been undertaken eg exposed backing to the power points within the roof space. We would recommend further inspection and subsequent repairs undertaken where required. Hazardous. Safety issue.
